JPL D-11383

NASA Unmanned Flight Anomaly Report

ANALYSIS OF UPLINK/DOWNLINK ANOMALIES ON SIX JPL SPACECRAFT

September 1994

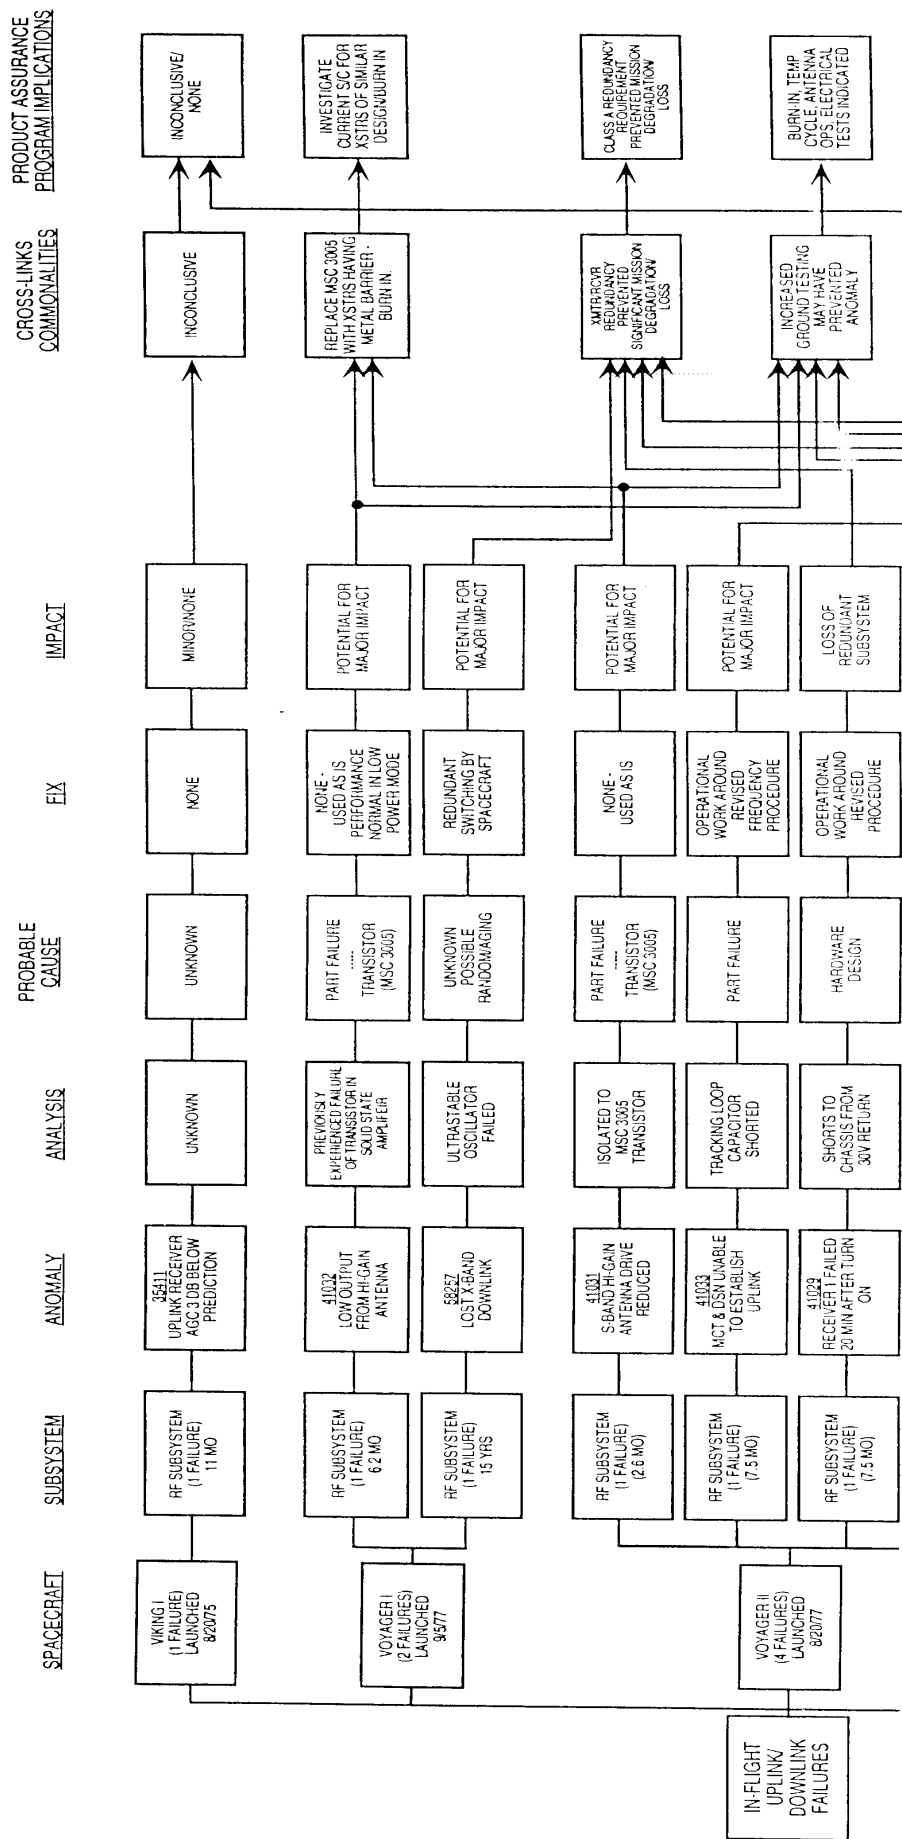
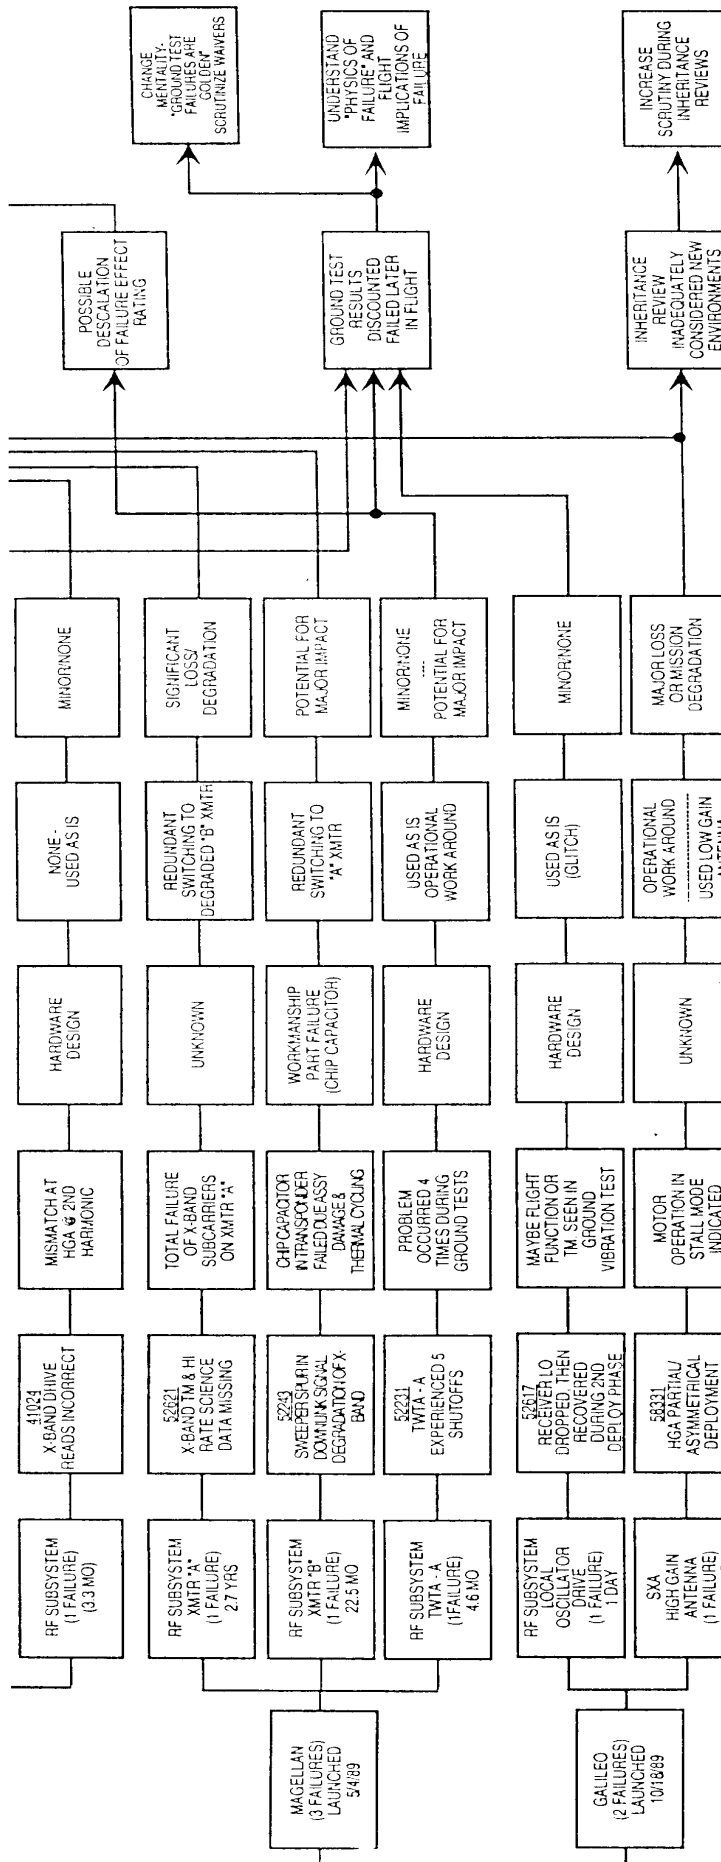
FIGURE 1

Figure 1 presents a flow diagram of all RF subsystem (RFS) anomalies that interrupted or seriously degraded the uplink/downlink process for the four JPL missions. In order to be included in Figure 1, an anomaly only had to interrupt or seriously degrade an important portion of the communications or science data stream; it did not have to cause complete loss of telecommunications data. Anomalies that appear to share a common "lesson learned" have been grouped as shown in Figure 1. The last column presents proposed ways of applying these "lessons learned" to future product assurance programs. Table 1 presents a summary of product assurance implications, extracted from Figure 1.

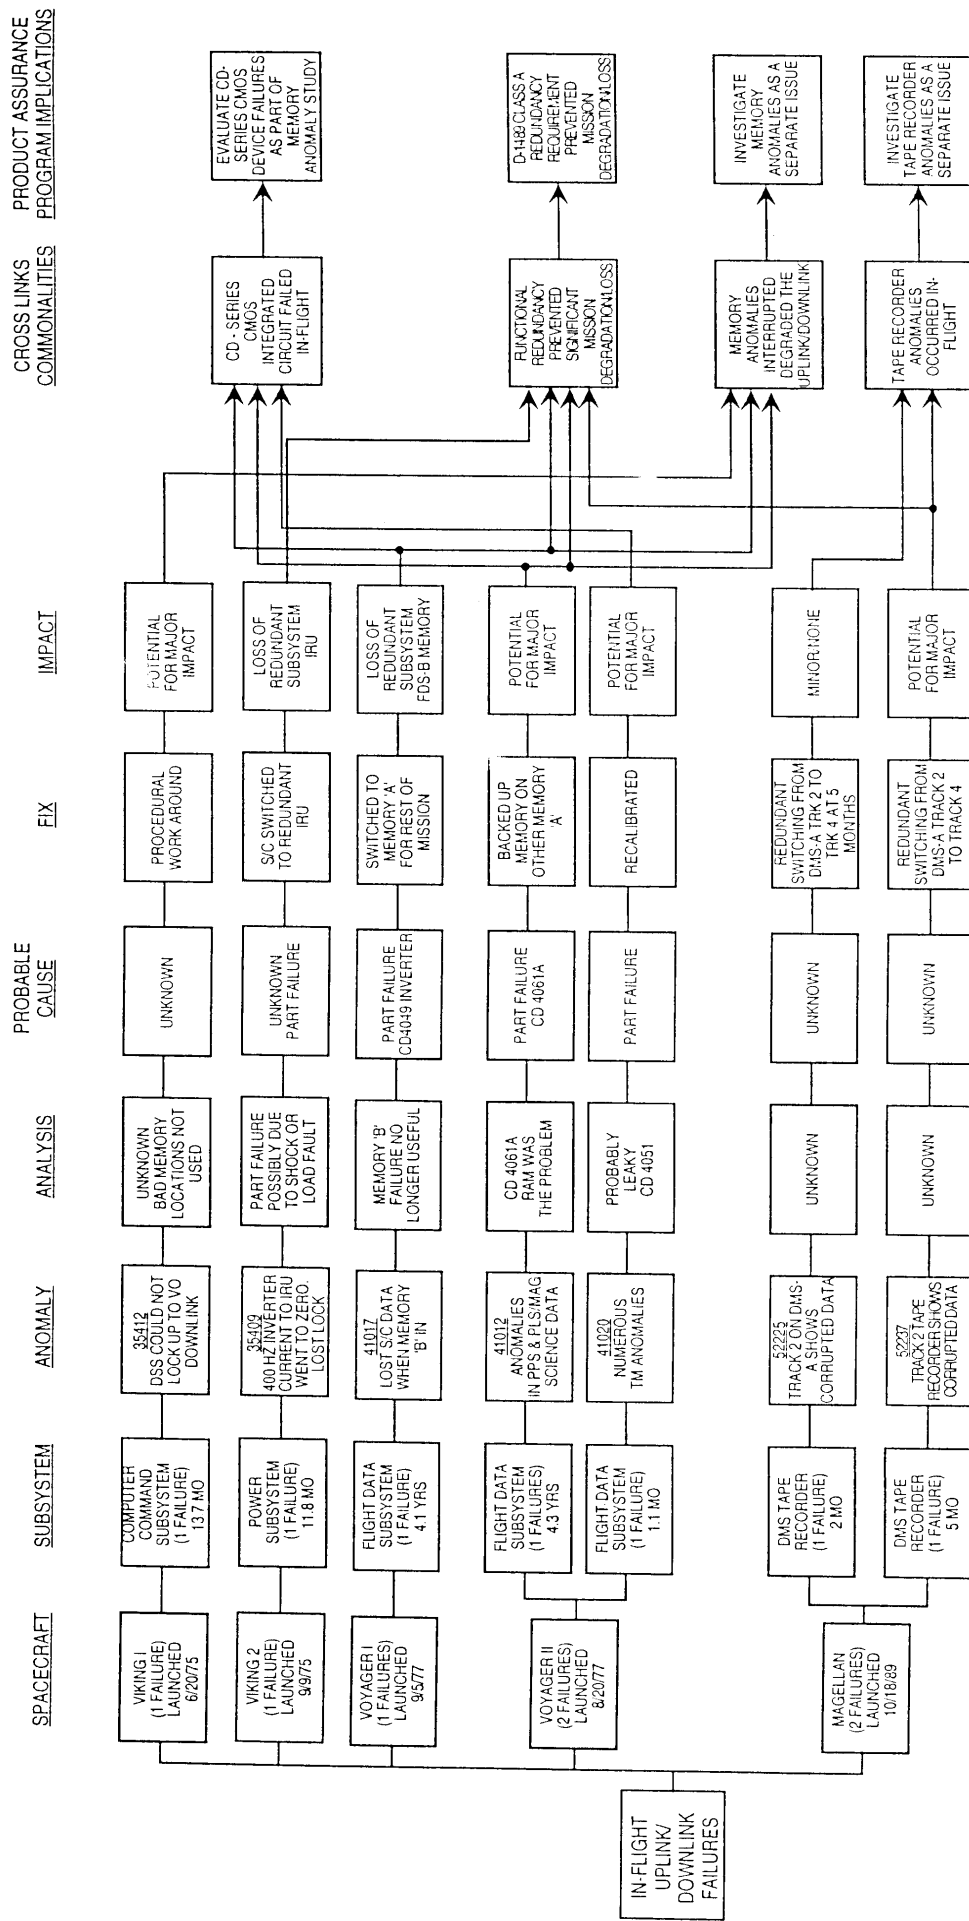
FIGURE 2

Figure 2 presents a similar flow diagram for all non-RFS anomalies that interrupted or seriously degraded the uplink/downlink data stream. Table 2 summarizes the product assurance implications of the analysis of non-RFS anomalies. The combined findings from both diagrams are discussed below.

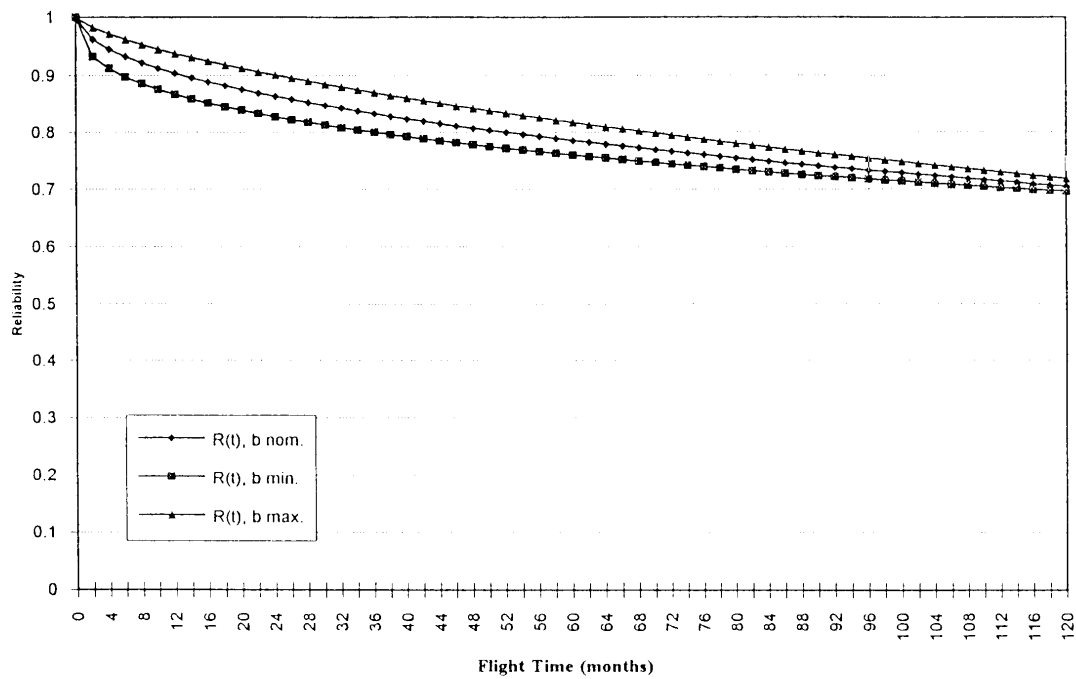
Figure 3
Probability of Success as a Function of Time from Launch in Months - RFS Failures

Quantifying this probability from such limited data provides little statistical confidence, but the data can give a certain "engineering feel" which might influence future decisions about spacecraft redundancy. Based on the data from the six JPL spacecraft studied, Table 3 shows eight failures which would have been catastrophic, except for redundancy. If only the RFS failures are considered, four failures would have effectively disabled Voyagers 1 and 2, Magellan and Galileo. Assuming that each of the six spacecraft had simple dual channel redundancy of critical functions, Milena Krasich calculated the probability of success for a single-channel system as a function of time from launch. The first plot is for RFS failures only and the second is for all catastrophic failures that interrupted the uplink or downlink data stream. These results are shown in Figures 3 and 4. A Weibull distribution (decreasing failure rate) was found to fit the data better than an exponential distribution (constant failure rate), and the figures assume the Weibull. The three curves in each figure give the 90% upper and lower confidence limits on the point estimate of the shape parameter β . Her calculations are reported in reference (5).

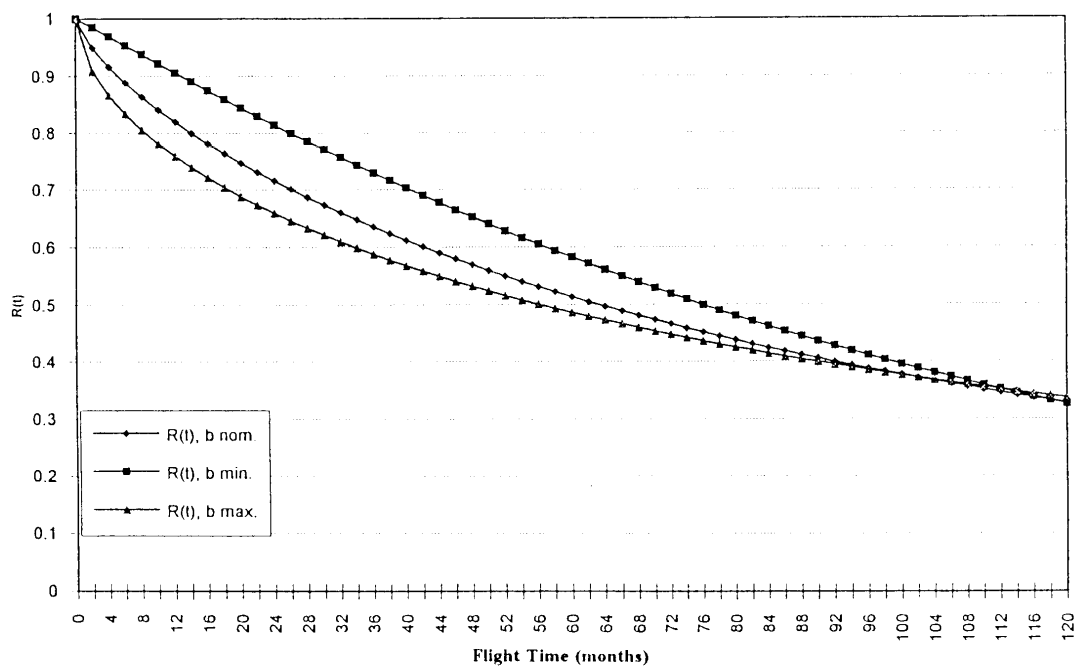
Figure 4
Probability of Success as a Function of Flight Time in Months - All Failures

It should be pointed out that these figures are based on very limited failure data and include only data stream and telecommunications failures. Inclusion of catastrophic failures (if they exist) in critical subsystems which are not associated with the uplink/downlink process will further reduce the estimate of mission success probability. The figures should be used cautiously, and supplemented with other data if available. Reference (3) reports data on earlier JPL programs which experienced substantially fewer telecommunications failures. Nevertheless, the data reported here represent the most recent twenty years of JPL flight history on Class A missions, and should certainly bear heavily on future decisions about telecommunications redundancy.
